检测报告
Test Report

Report No. A2230601380101E

样品名称	19 吋机柜[RA-15U(42U)-750]
Sample Name	19 吋机柜[RA-15U(42U)-750]
表面处理	细织纹烤漆 PANTONE 4U
Surface treatment	fine textured paint PANTONE 4U
材料	SPCC/AL 6063 T5
Material	SPCC/AL 6063 T5
样品接收状态	正常
Sample Receiving State	Normal
样品接收日期	2023.11.17
Sample Received Date	Nov. 17, 2023
样品检测日期	2023.11.17-2023.11.23
Testing Period	Nov. 17, 2023-Nov. 23, 2023

Test Item: Compression test

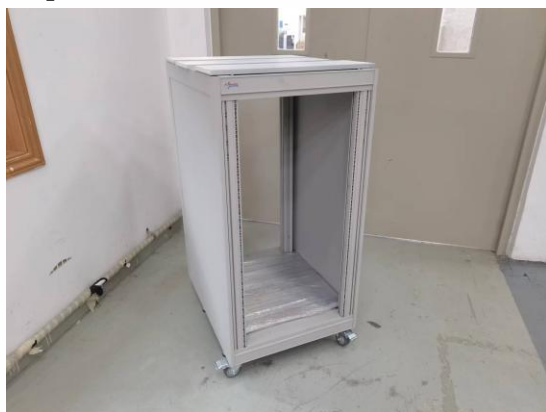
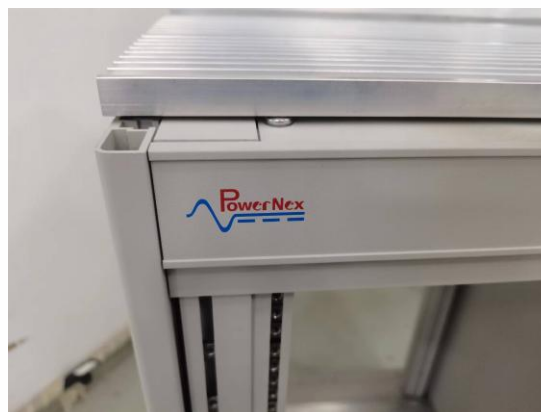
样品编号 Sample No.	样品名称 Sample Name	样品数量 Quantity
A2230601380101001	19 吋机柜[RA-15U(42U)-750] 19 吋机柜[RA-15U(42U)-750]	1pc

样品图片

Sample Photo(s)

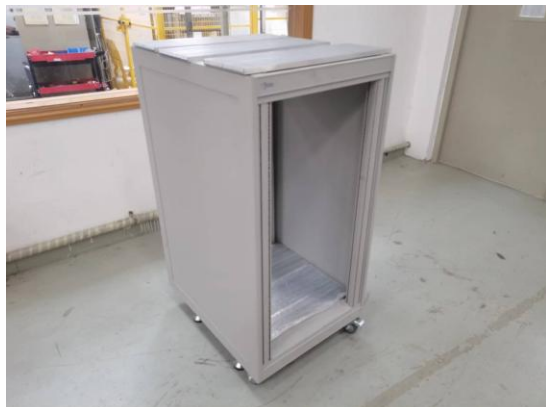
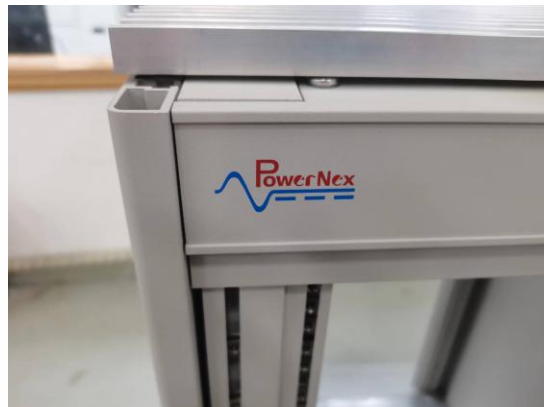
样品编号 Sample No.	判定依据 Judgment basis	测试结果 Test result	结论 Conclusion
A2230601380101001	无明显损坏。 No obvious damage	测试后, 目视检查样品外观无损坏。 After testing, visual inspection the appearance of the sample is intact.	符合 Pass

测试后样品图片

Sample Photo(s) after the test

荷重 1050kg, 保持 24 小时。

Load 1050kg, keep for 24 hours.
